**SITE OF HOUSE AND STABLES, AND DRIVE**

**HS1**

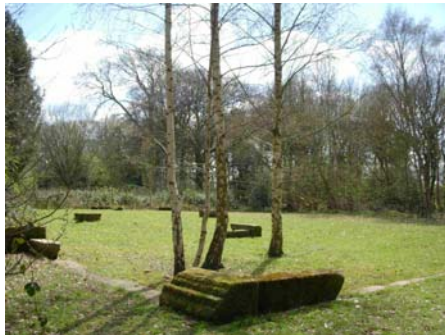
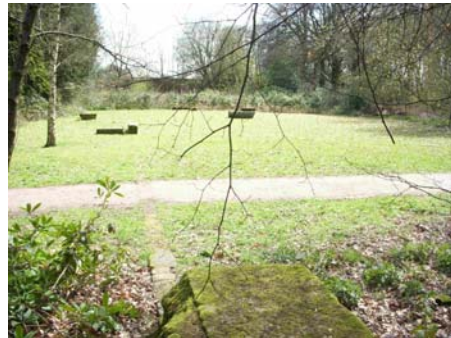
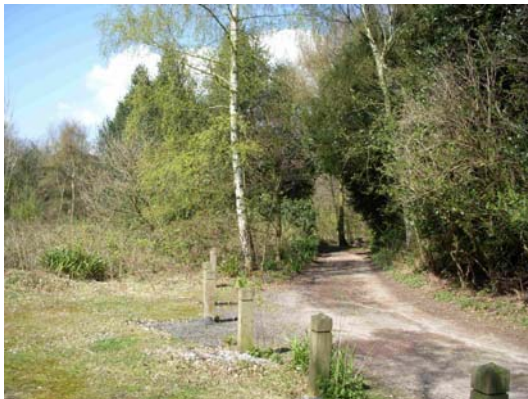
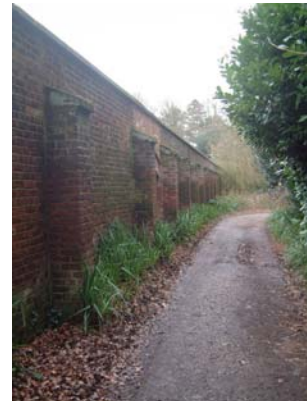
- Site of Grappenhall Heys house: the derelict house was demolished in the 1970s. The site was investigated in the 1990s as part of the development of a network of public open spaces for adjacent residential areas. The footprint of the house walls was marked with stone blocks (from the house) set into the grass. Pieces of dressed stone which had formed the portico and other detailing of the neo-classical house were set into the footprint. The corner of the portico marks the corner of the main entrance facing towards the drive.

- The stables and ancillary buildings: from historical maps, these appear to have been between the house and the Walled Garden. Currently they are an area of woodland and hard-standing. No investigation has been carried out here. This site and that of the house are now owned by the Woodland Trust.

- The drive: remains in situ as a track. It leads from the extant western lodge, past the porch, stables and round the outside of the Walled Garden. It is owned by Warrington Borough Council.

- Sites and track not within the ownership of the Parish Council
- Some of the stables/ancillary buildings site may be required to provide disabled/staff parking
- Current condition and construction of the drive/track poor; will not sustain increased usage

Archaeology prior to creation of small parking area?

- Education - achieve improved interpretation and use of the historic estate; develop relationship with Woodland Trust to further this aim
- Parking - achieve improved parking; develop relationship with Woodland Trust to further this aim
- Access - achieve an improved access; develop relationship with Warrington Borough Council to further this aim

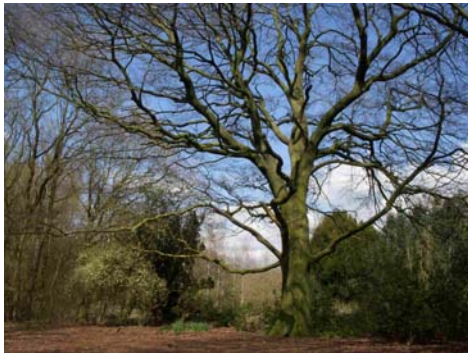
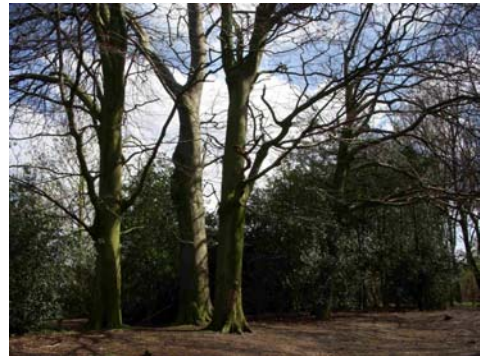
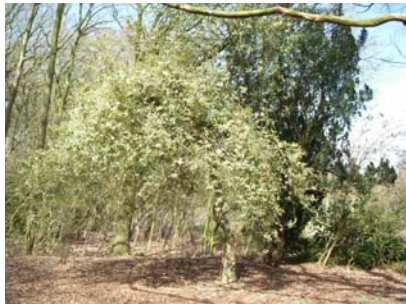
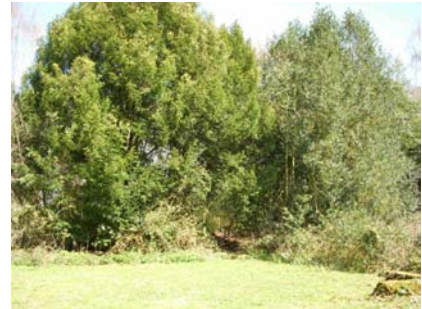
**HS2**

- Formal gardens: from historical OS maps and photographs, three lawns lay between two terraces on the south side of the house, plus a bowling green on the lowest level. The extensive lawns were framed by groups of ornamental trees and shrubs.

- Relict trees and shrubs: relict mature Beech, Holly (one variegated), Rhododendron and Yew (one fastigate) remain in situ, surrounded by younger woodland which has developed since the demise of the house. The whole area is now owned by the Woodland Trust.

- Screen planting south of the stables: from the OS map of 1875 apparently mixed trees and shrubs of which 3 mature Beech (vandalised) and Holly remain.

- Planting north of the bowling green and side of conservatory: from 1875, appears to be predominantly large shrubs with a few trees. Yew remain and 1 low-branched Beech.

- Either side of porch: young woodland only.
- North of stables, (opposite side of track): mature Holly, Yew and Rhododendron varieties.

- Sites not within the ownership of the Parish Council
- Overall condition fair; some of the sites are subject to vandalism and the base of the trees to compaction due to cycling and skate-boarding

- Education: develop relationship with Woodland Trust to foster interpretation, outreach and thereby ameliorate misuse of the sites if possible

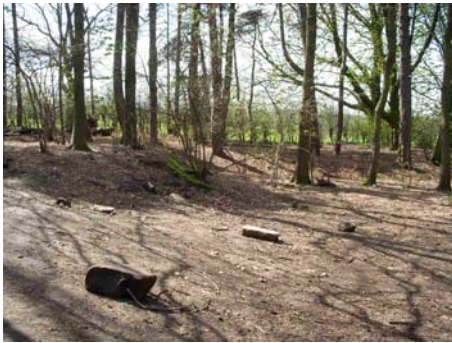
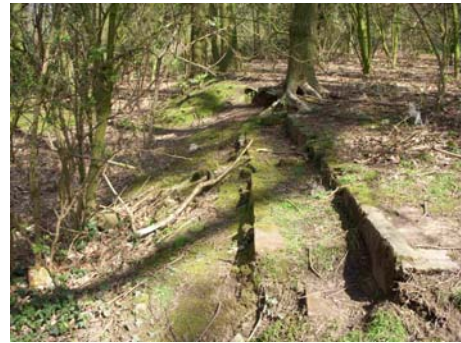
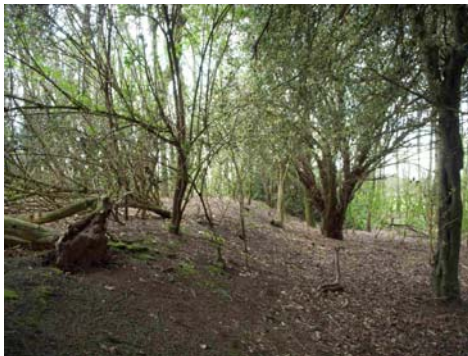
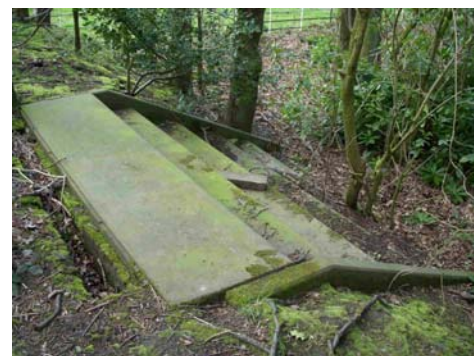
**HS3**

- Formal gardens, terraces: from historical maps and photographs, three lawns lay on terraces on the south side of the house, connected by two short flights of steps. The steps were removed in the 1980s and basically only the slopes between the terraces remain. They are subject to erosion and vandalism caused by the use of mountain bikes and skate boards.
- Upper slope: ground form remains but few foundations left.
- Middle slope: ground form and foundations remain.
- From the lowest lawn, another, steeper slope dropped down to a bowling green.
- Lowest slope: ground form and almost complete flight of steps to bowling green remain. This is the only extant set of steps (dressed stone), somewhat protected by the woodland which has developed on all the lawns and the green. It appears to have been the longest flight of steps.

- Sites not within the ownership of the Parish Council
- Overall condition poor; two sets of steps removed, terraces subject to vandalism/erosion by cycling and skate-boarding
- Last remaining set of steps in tact, but unsafe and at risk of theft

Repair? Relocate?

- Education: develop relationship with Woodland Trust to foster interpretation, outreach and thereby ameliorate misuse of the sites if possible
- Conserve steps in situ

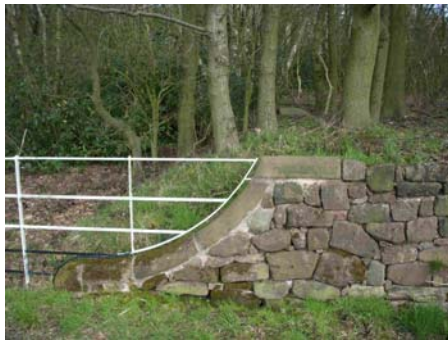
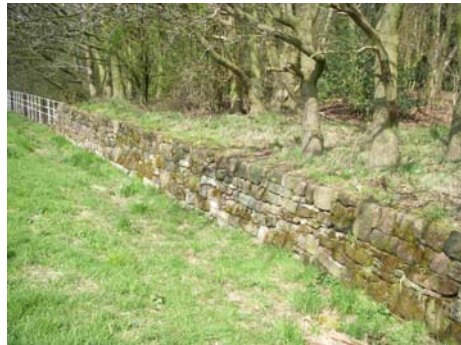
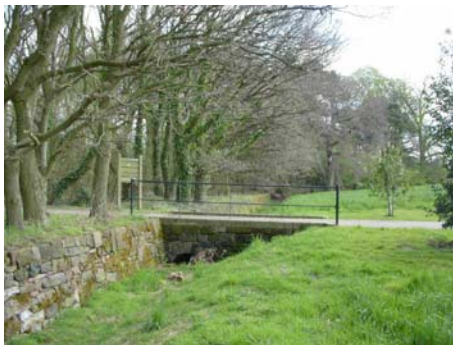
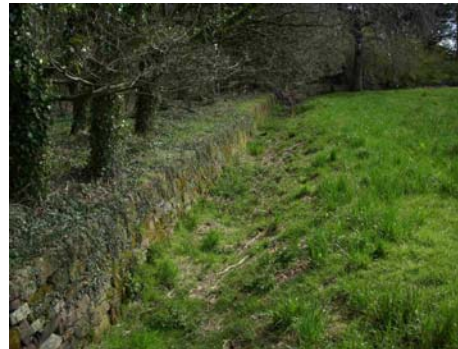
**HS4**

- Ha-ha: from historical maps this remains in situ and runs the full extent of its original length. It divided the formal gardens to the north east from the parkland to the south west, thereby preventing the entry of any stock. It is a rubble red sandstone retaining wall which supported the formal garden to the rear, with a grassed ditch in front of it. It runs at a right angle to the three slopes.
- The extant set of steps to the bowling green site are immediately to the rear of the step down in the (repaired) coping.
- Woodland is now on the site of the lawns, and is owned by the Woodland Trust.
- The ditch of the ha-ha was bridged in early 2000s.

- Site not within the ownership of the Parish Council
- Overall condition good, but locally poor and vandalised

Interpret and repair

- Education: develop relationship with Woodland Trust to foster interpretation, outreach and thereby ameliorate misuse of the site if possible
- Repair ha-ha
