**GLASSHOUSES: FITTINGS – OPENING MECHANISM AND BRACKETS**

**GH1-8**

## GLASSHOUSES: CELLARS & BOILERS

## GLASSHOUSES: BACK-SHEDS

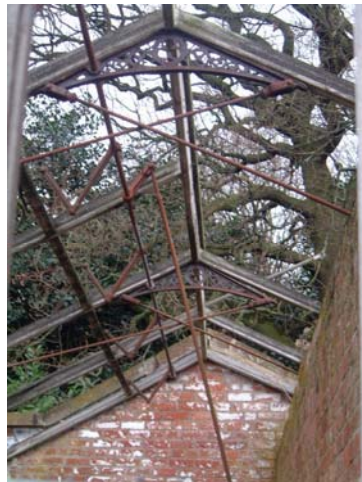
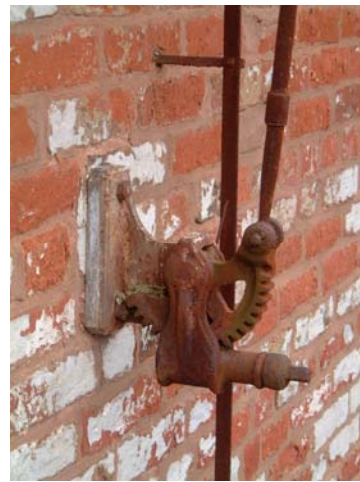
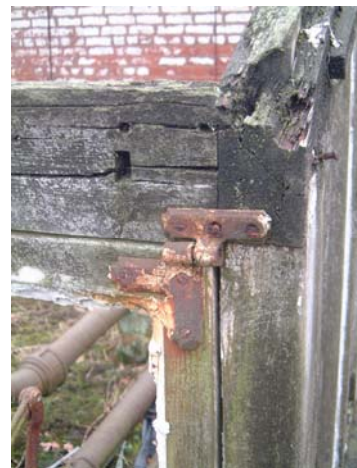
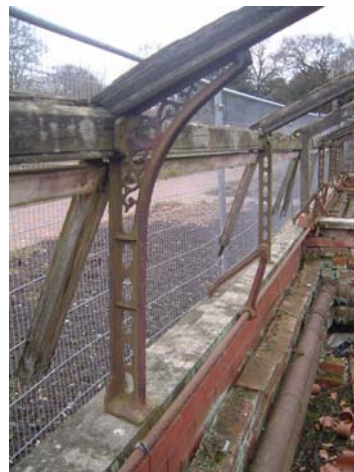
- Roof timbers, metal struts, ornamental brackets and roof light opening mechanism (GH1)
- Winding handle and ratchet for roof lights (GH1)
- Gable end and south-facing timbers, lower light casement and hinge (GH4)
- Lower lights, brackets, sill and pipework (GH4)

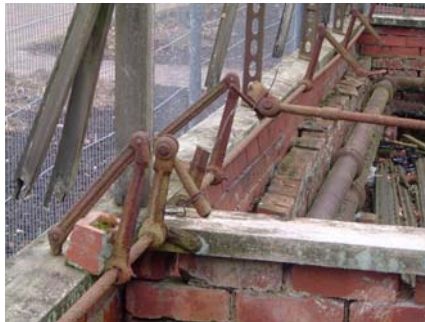
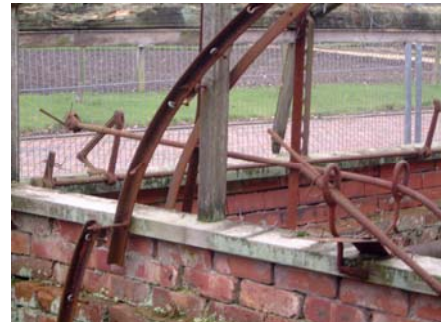
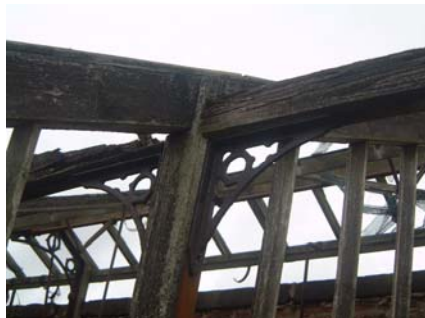
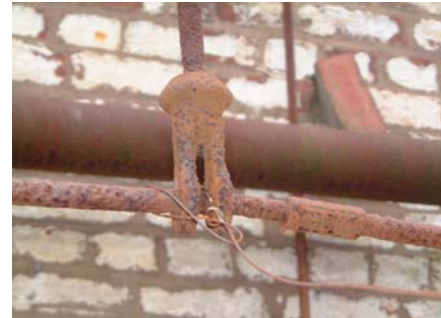
**GH1-8**

- Lower light opening mechanism (GH2, 3, 4)
- Peach tree training arches and lower light opening mechanism? (GH5 and 6)
- Roof timbers and ornamental brackets at a junction (GH5 and 6?)
- Training support (GH5 and 6)

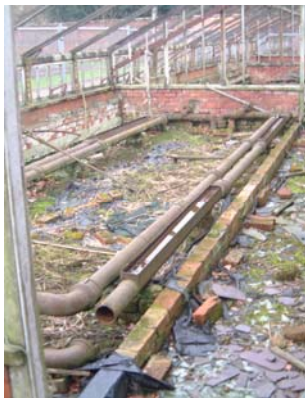
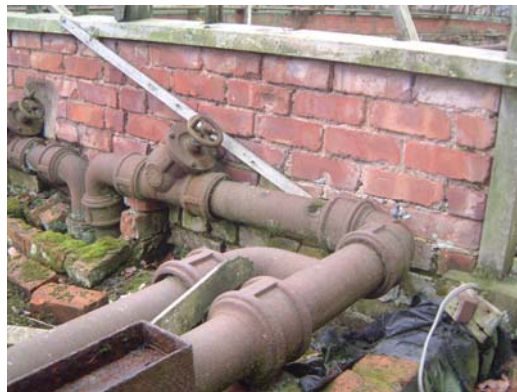
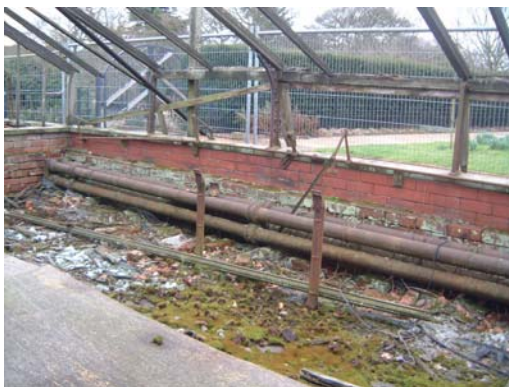
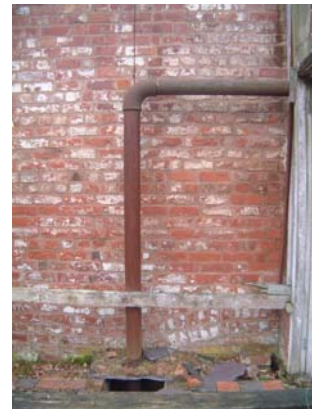
**GH1-8**

- Heating pipes with humidifying trays (GH4)
- Detail of above (GH4)
- Heating pipes and staging brackets in foreground (GH7)
- Heating pipe from boiler in cellar (GH3?)

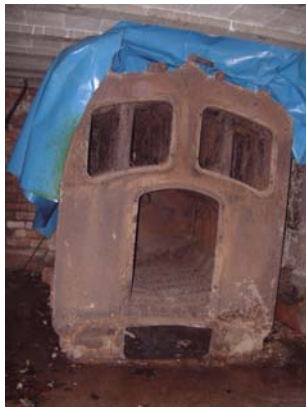
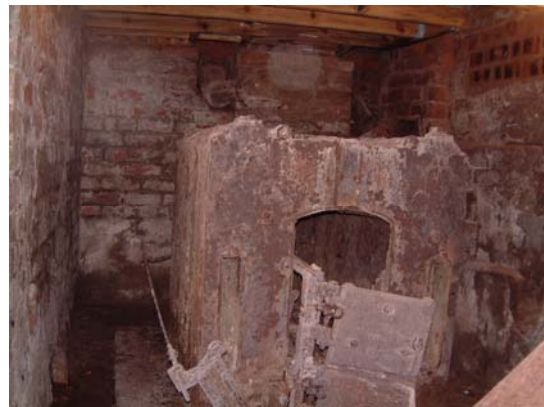
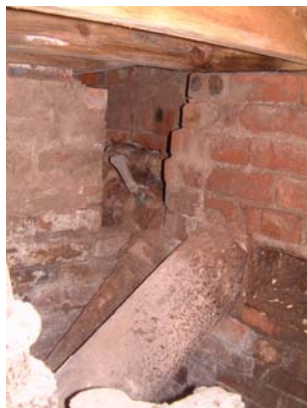
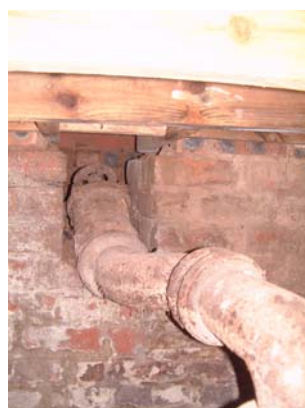
GH9 and 10

The boilers are situated in the cellars under the back-sheds, the support buildings at the rear of the glasshouses. Historical maps show that glasshouses covering only the western half of the range in 1875, but the full existing length by 1899. This may explain why there are two boilers, not one.

- Boiler in re-pointed brick cellar below artefacts storeroom (rear GH7 and 8)
- Boiler in re-pointed brick cellar below classroom (rear of GH2 and 3)
- Inlet and outlet pipes from cellar into GH7 and 8?
- Pipe from cellar into GH2 and 3?

- Condition derelict
- Public safety, access currently not possible
- Sustainable energy source required

- To re-develop the glasshouses in a way that exemplifies sustainability in terms of building design and energy consumption using the specific microclimate benefits created by a south-facing range of buildings and a walled space, such as solar power and/or ground-source heat pumps
- For educational purposes, improve access and interpretation so that at least one boiler is retained and a cellar can be visited, which may be a unique offering with reference to the other walled gardens in the area

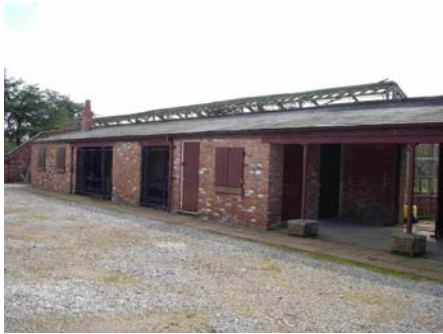
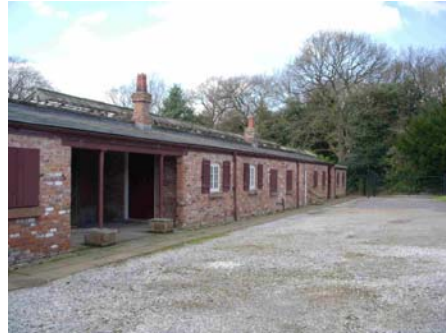
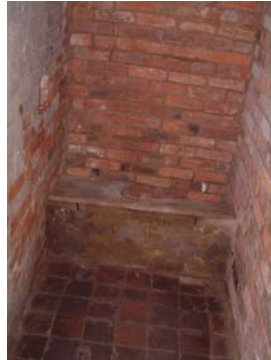
GH11

- The support buildings at the rear of the glasshouses are referred to as the 'back-sheds'. Historical maps show that like the glasshouses they were located on the central portion of their current length in 1875, but they were extended to the end of the new glasshouses in 1899.

- After 50 years of dereliction they were completely re-built in 2000 on the original footprint, except for the back wall which is shared with the glasshouses and was mostly re-pointed. They are brick and slate construction with timber floors, except for 'the bothy' (gardener's living accommodation) which is concrete.

- The two integral passageways between the yard and the Kitchen Garden were retained. The fireplace in the bothy remains, since this is on the back wall. The fittings and tiles of 'the privy' have also been re-instated.

- The westernmost shed was in two sections, one half brick, the other timber. An entirely brick building, matching the others, was erected on the site of this in 2000.

- Condition fair; completely re-built but require protection of south wall to be fully functioning
- Public use; currently fitted out to a minimum usable standard
- Shortage of covered, usable space
- Sustainable energy source required

- To re-develop the backsheds as integral part of the glasshouses (as they were), in a way that exemplifies sustainability in terms of building design and energy consumption using the specific microclimate benefits created by a south-facing range of buildings and a walled space, such as solar power and/or ground-source heat pumps
- To re-configure and fit out as spaces which can be used for education and community purposes, whilst retaining some features of their last uses, see below
- For educational purposes, retain the privy, bothy and gardener's office and improve interpretation; an understanding of glasshouses as a working environment may again be a unique offering in comparison with the other walled gardens in the area
- Due to the lack of covered space in the garden the back-sheds also need to fulfil the functions of storage and office spaces
