**GLASSHOUSES: FITTINGS – OPENING MECHANISM AND BRACKETS**

**GH1-8**

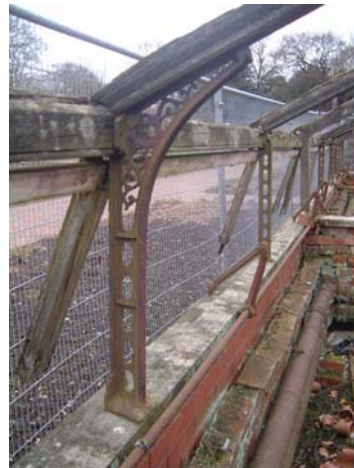
- Roof timbers, metal struts, ornamental brackets and roof light opening mechanism (GH1)
- Winding handle and ratchet for roof lights (GH1)
- Gable end and south-facing timbers, lower light casement and hinge (GH4)
- Lower lights, brackets, sill and pipework (GH4)

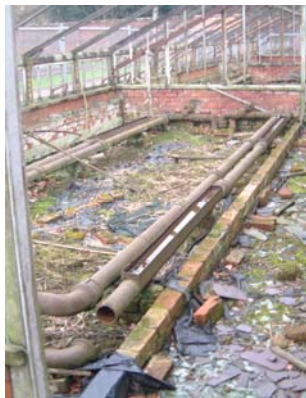
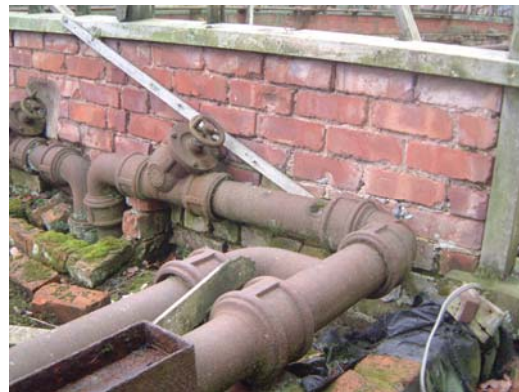
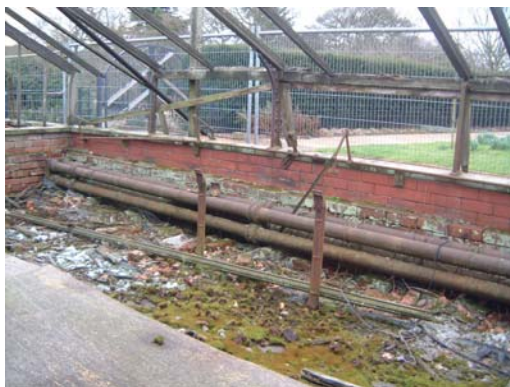
- Heating pipes with humidifying trays (GH4)
- Detail of above (GH4)
- Heating pipes and staging brackets in foreground (GH7)
- Heating pipe from boiler in cellar (GH3?)

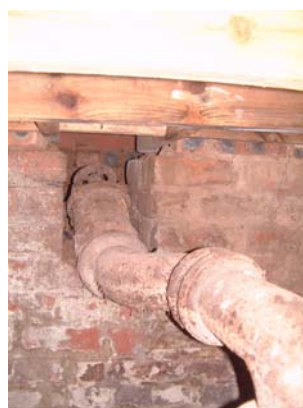
GH9 and 10

The boilers are situated in the cellars under the back-sheds, the support buildings at the rear of the glasshouses. Historical maps show that glasshouses covering only the western half of the range in 1875, but the full existing length by 1899. This may explain why there are two boilers, not one.

- Boiler in re-pointed brick cellar below artefacts storeroom (rear GH7 and 8)
- Boiler in re-pointed brick cellar below classroom (rear of GH2 and 3)
- Inlet and outlet pipes from cellar into GH7 and 8?
- Pipe from cellar into GH2 and 3?

- Condition derelict
- Public safety, access currently not possible
- Sustainable energy source required

- To re-develop the glasshouses in a way that exemplifies sustainability in terms of building design and energy consumption using the specific microclimate benefits created by a south-facing range of buildings and a walled space, such as solar power and/or ground-source heat pumps
- For educational purposes, improve access and interpretation so that at least one boiler is retained and a cellar can be visited, which may be a unique offering with reference to the other walled gardens in the area
