## KITCHEN GARDEN: BOUNDARIES

### KG 1

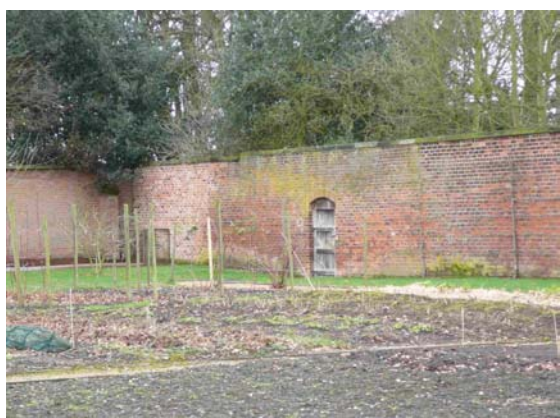
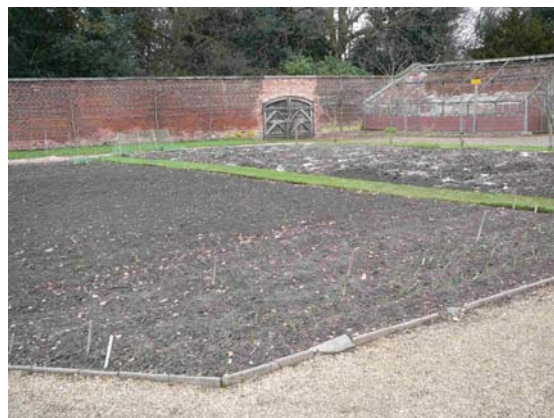
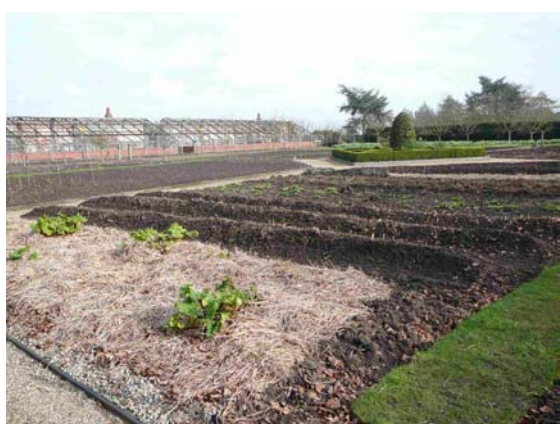
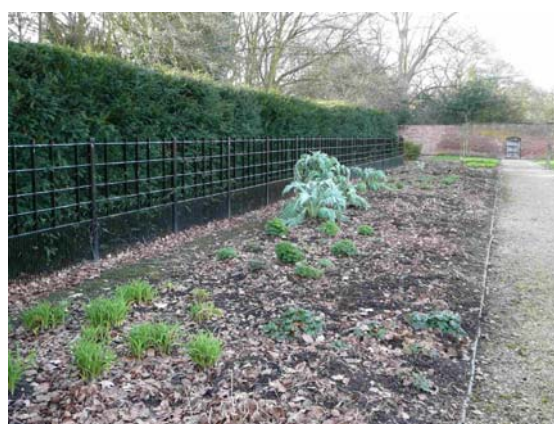
- Southern boundary western section: brick wall with stone coping, re-built in-situ in the late 1990s with new bricks and original copings to match extant Victorian detail.
- Western wall: brick with stone coping, majority re-pointed in the late 1990s, section above vehicular gate re-built
- Northern wall: back wall common to both the glasshouses and the support buildings ('back-sheds'), majority re-pointed. Upper 20% re-built with new bricks and original copings in early 2000s.
- Eastern boundary and southern boundary eastern section: Victorian Yew (*Taxus baccata*) hedge, probably planted by 1875 (Ordnance Survey map), returned to conventional dimensions by remedial pruning in the late 1990s.

- None, boundaries recently repaired/rebuilt with original/authentic materials; endowment covers cost of maintenance.

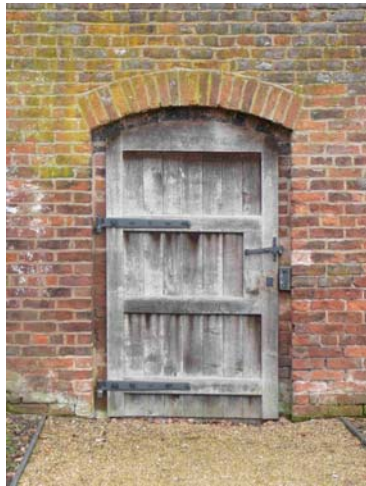
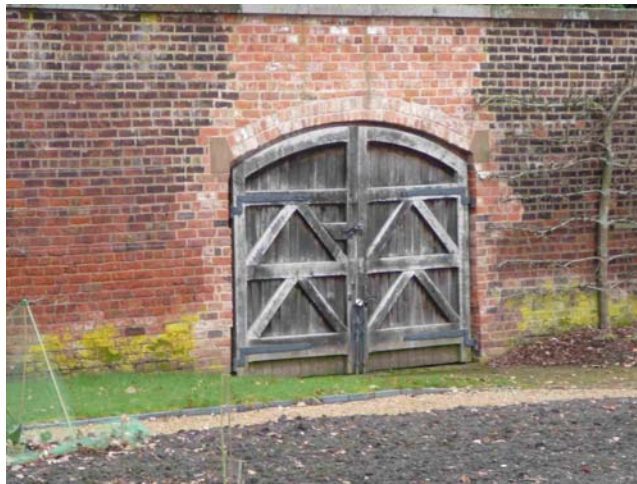
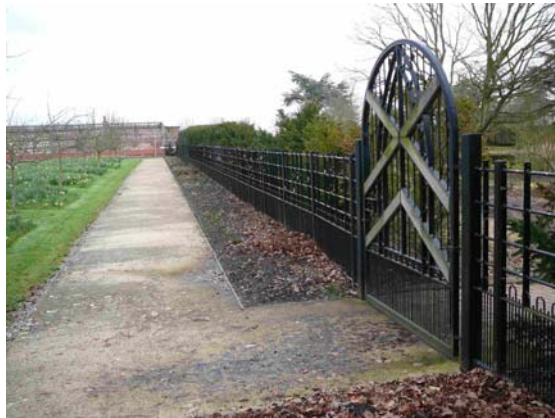
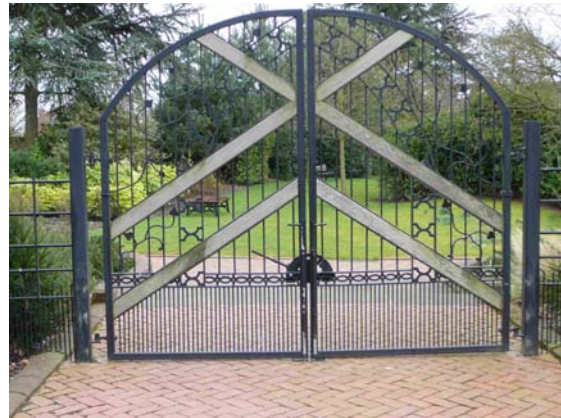
KG 2

- Southern wall: one pedestrian, braced, oak gate with metal fittings, copied from extant Victorian detail in-situ, constructed in the late 1990s.
- Western wall: one pedestrian and one vehicular, braced, oak gates, both with metal fittings, as above.
- Northern wall: two pedestrian, braced, oak gates with metal fittings, as above.
- Eastern boundary: galvanised metal railing based on extant Victorian detail on the estate. Two metal and timber gates constructed in the early 2000s, one single, one double, both of contemporary design.

- Minor; modern metal fencing redundant with current supervised opening, could be removed if proves to be compatible with evolving uses. Endowment covers cost of maintenance

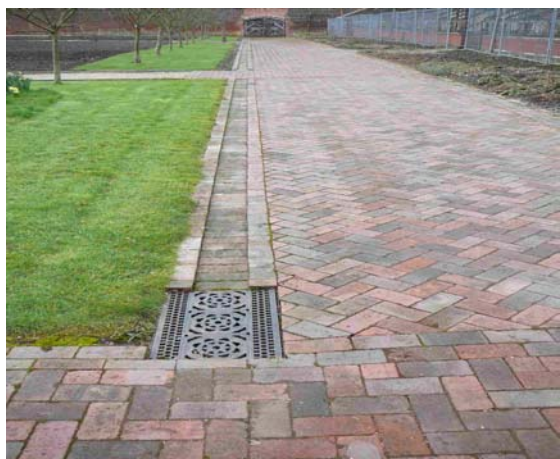
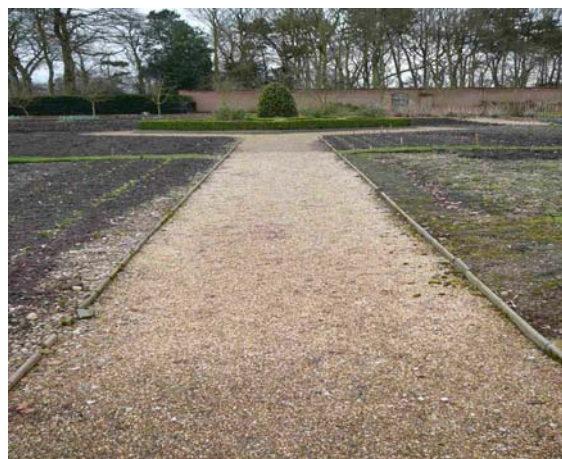
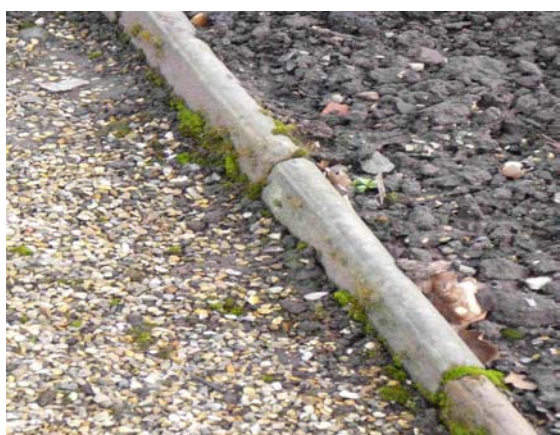
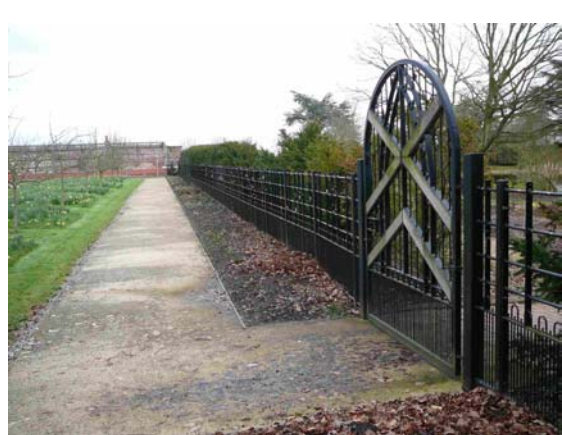
KG3

- OS maps of 1875 and 1899 the Kitchen Garden in its current location and roughly square, but show no internal divisions.
- The productive area was divided into quadrants by four cruciform paths in the refurbishment of the early 2000s. The gravel and tile edging detail are based on the materials extant in this part of the Garden.

- The path to the north of the quadrants runs along the front of glasshouses and is brick paver, (Furness Brick Weathered Red 205), laid to a herringbone pattern in the early 2000s.

- The path to the east of the quadrants is resin-bound golden gravel which replaced the unbound gravel to provide improved wheelchair/buggy access in 2005.

- The path to the south of the quadrants is golden gravel, as per the cruciform path.
- The brick path contains inset cast iron drainage grills, copied in the early 2000s from extant ones on site. Originals remain in the glasshouses.

- None; endowment covers cost of maintenance

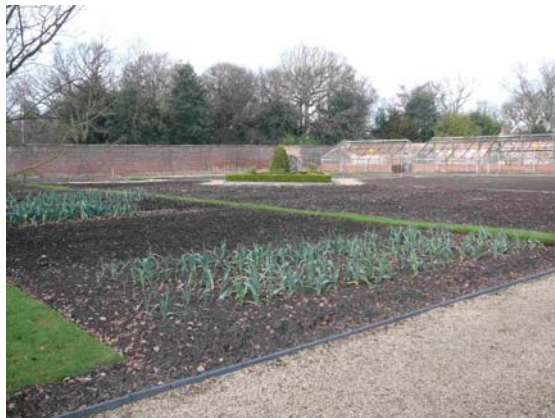
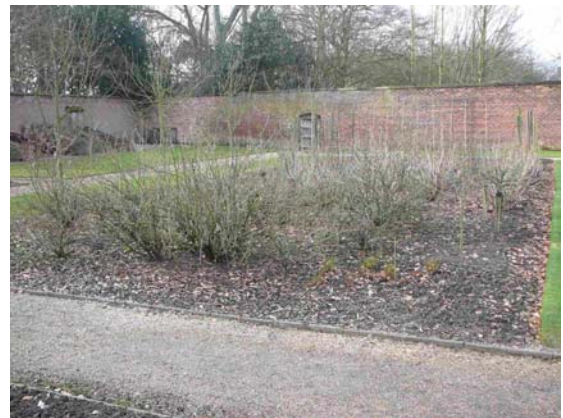
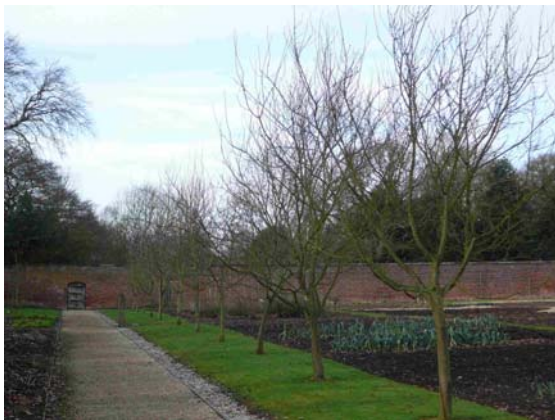
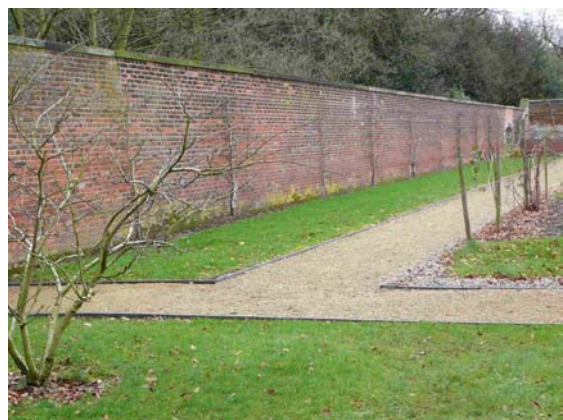
### KG 4

- Quadrants: four large beds bisected by a cruciform footpath constructed in the early 2000s as described above.
- South west quadrant dedicated to soft fruit, other quadrants to crops of traditional varieties of vegetables and cut flowers, sown annually.
- West of quadrants: traditional varieties of Pear, trained as espaliers on the western wall, based on the extant Victorian detail in-situ and re-planted in the late 1990s.
- North, south and east of quadrants: traditional varieties of Apple, Plum and other top fruit, planted in grass in the late 1990s.

- Financial - endowment does not cover cost of retaining a vegetable and soft fruit producing area; volunteers therefore essential for this part of the kitchen garden
- Manpower - productive gardens are labour-intensive and a team of volunteers is required to assist the gardener in achieving a planted and maintained area

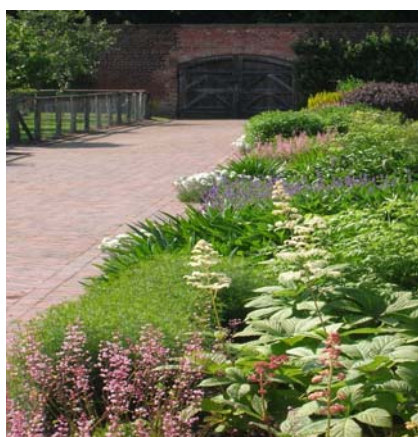
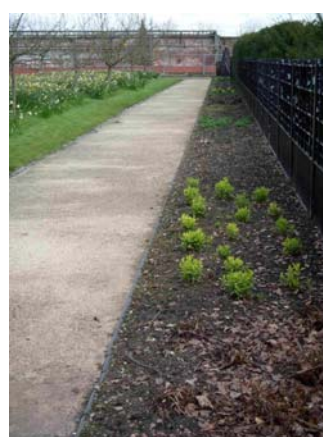
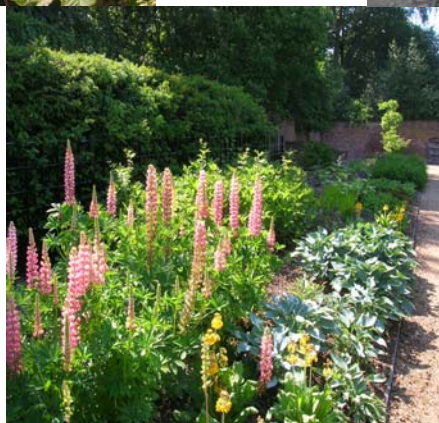
**KG5**

- Borders of herbaceous perennials form the outer planting of the Kitchen Garden on 3 of its 4 sides. This arrangement is based on an historical photograph of the Garden when owned by the Parrs, showing the footpath in front of the glasshouses and the productive area surrounded by an ornamental border. Some of this appeared to be bedding plants, and herbaceous perennials were chosen as a more sustainable, lower maintenance approach
- Northern border in front of glasshouses: mixed herbaceous perennials suitable for sunny border, planted in 2002-5
- Southern border in front of Yew hedge: mixed herbaceous perennials suitable for shade and heavier soil, planted in 2002-5
- Eastern border in front of Yew hedge: mixed herbaceous perennials suitable for sun and narrow border, planted in 2002-5.

- None; endowment covers cost of maintenance, and maintenance is also assisted by volunteers
